# BEAR CREEK CORRIDOR GEOHAZARD SLOPE STABILITY AND EROSION ASSESSMENT

GRANDE PRAIRIE, ALBERTA

THE CITY OF GRANDE PRAIRIE

PARKLAND GEOTECHNICAL LTD.

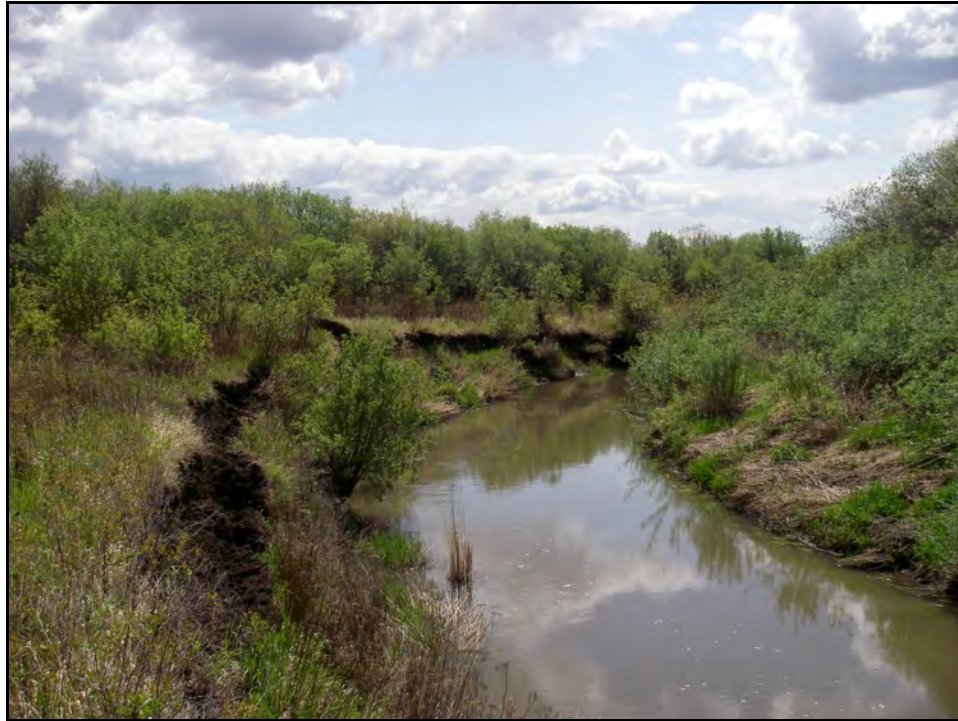
**Photograph 3:** Typical slumps along creek along the entire creek from 132 Avenue to the northern City Limit. The typical valley depth from upland to water elevation is typically less than 3 m along much of this section. Some beaver activity observed.

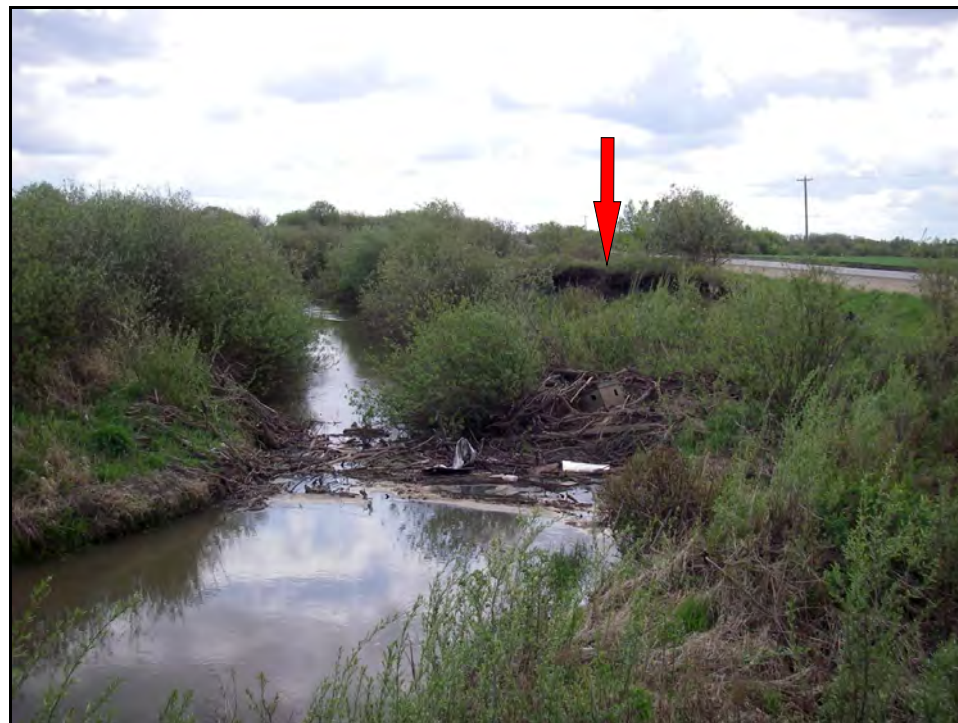
**Photograph 4:** Beaver activity and erosion near 116 Street. Failure scarp noted with arrow. Beaver activity is causing increased water velocity in some areas, resulting in slope instability; however, this is not a major cause of failures in this area.

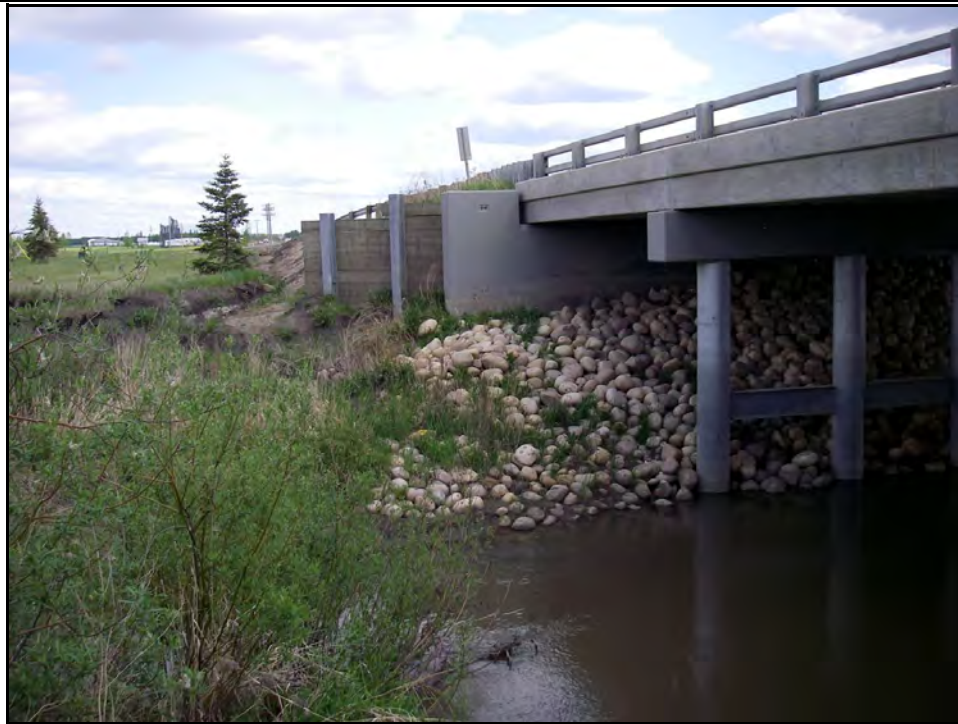
**Photograph 5:** Bridge at 132 Avenue looking east. Minor tension cracks indicative of slope movement were observed adjacent to the east and west abutments, on the north side of the bridge. This areas should be monitored for future movements.

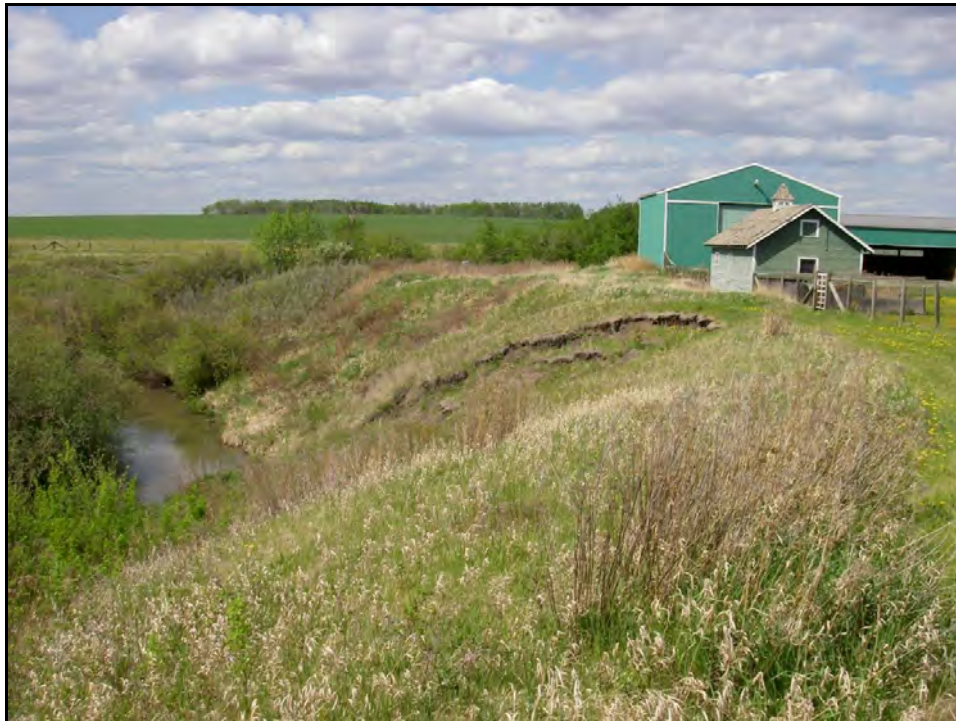
**Photograph 9:** Slope failure by the barn located on the farm west of 108 Street and 200 m south of 132 Avenue. Two failure scarps were present with the closest failure within 5 m of the barn.

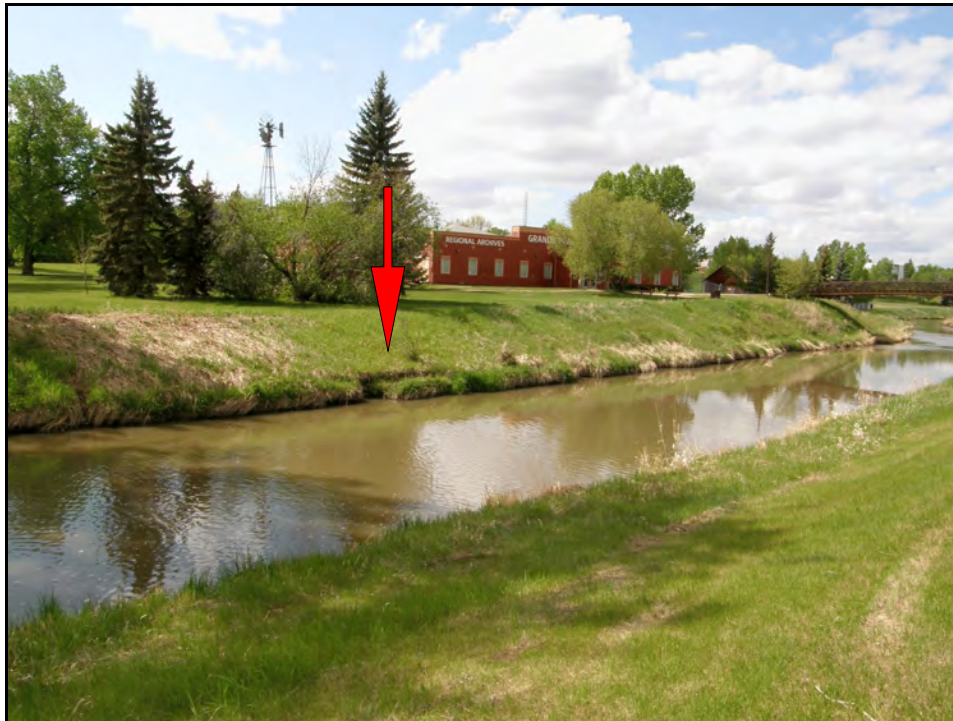
**Photograph 13:** Straight section of Bear Creek, looking northwest at the Museum. A few minor slope failures (arrow) were located along this section of the creek towards the 100 Avenue bridge.

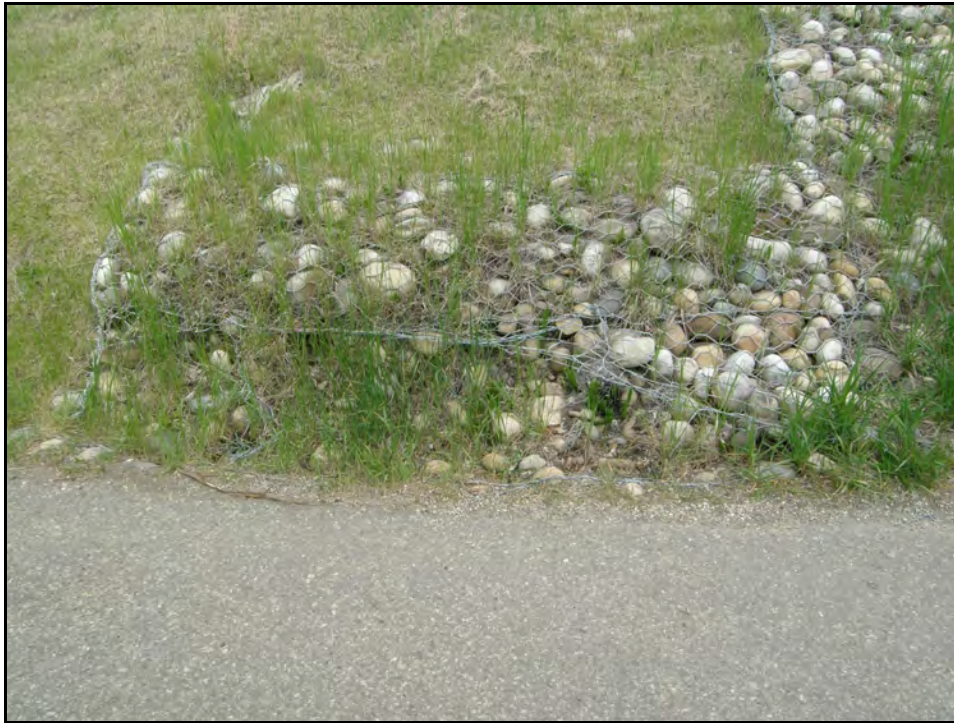
**Photograph 17:** Gabions at the 100 Avenue bridge, located upslope of the bike path (bottom of photograph). The gabions are in good condition but subject to some vandalism, as large rocks have been removed from the baskets.

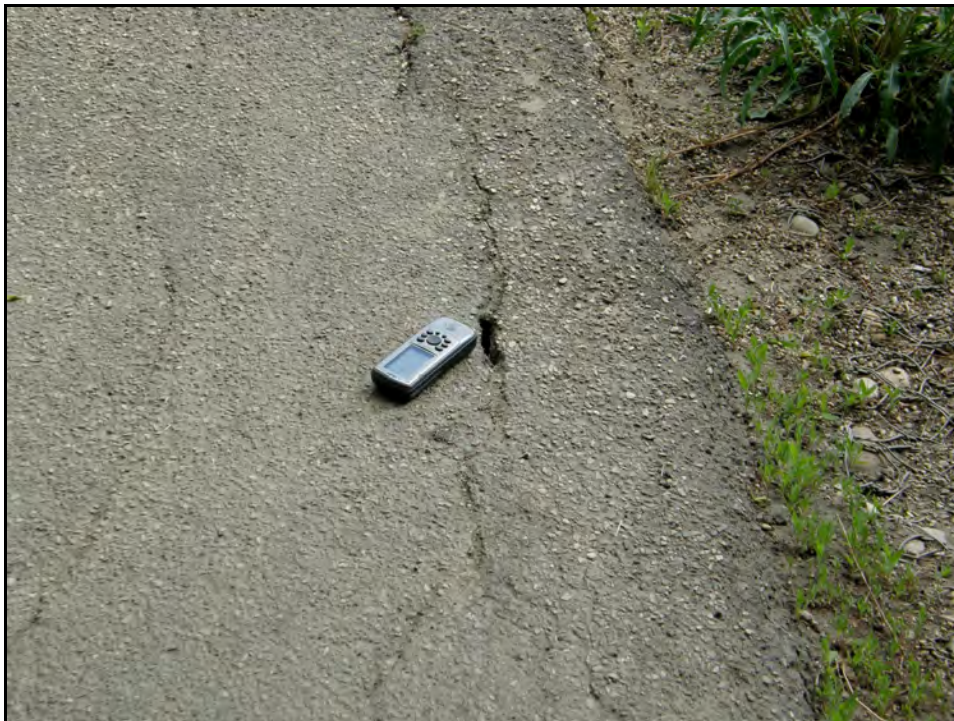
**Photograph 18:** Tension crack at 100 Avenue bridge in the paved bike trail (east side of creek). The tension cracks are indicative of slow creeping slope movement and are a maintenance issue. Cracks should be filled to minimize water infiltration and for safety purposes.

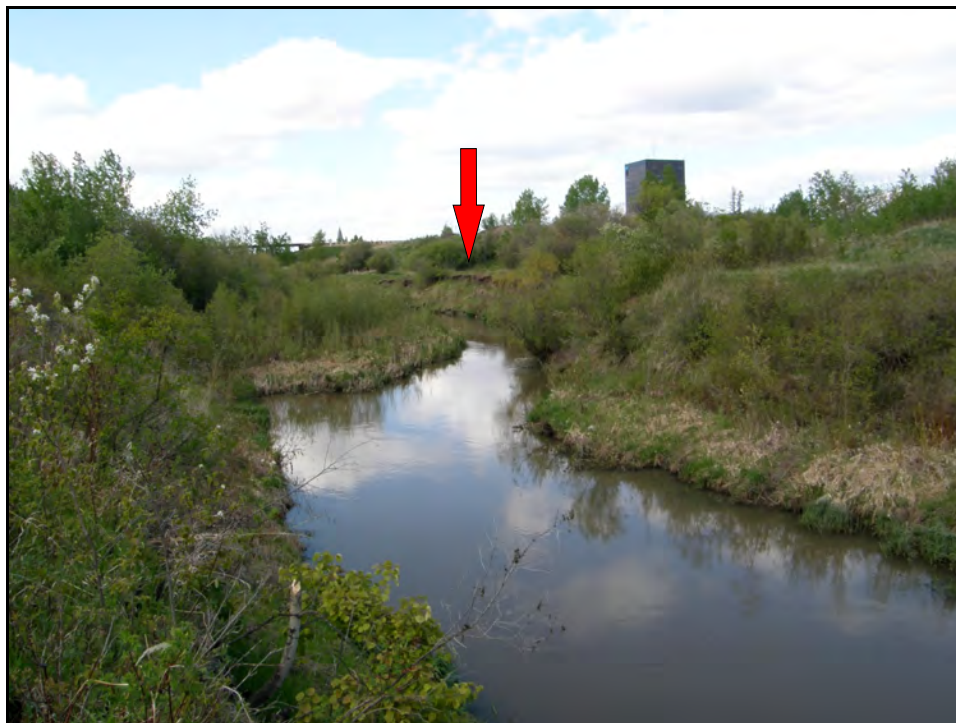
**Photograph 22:** Looking north along Bear Creek. Grass covered landslide debris indicates that this portion of the stream has stabilized within the recent past, likely due to reduced stream flows allowing vegetation to establish. A more recent slope failure is visible in the background (arrow).

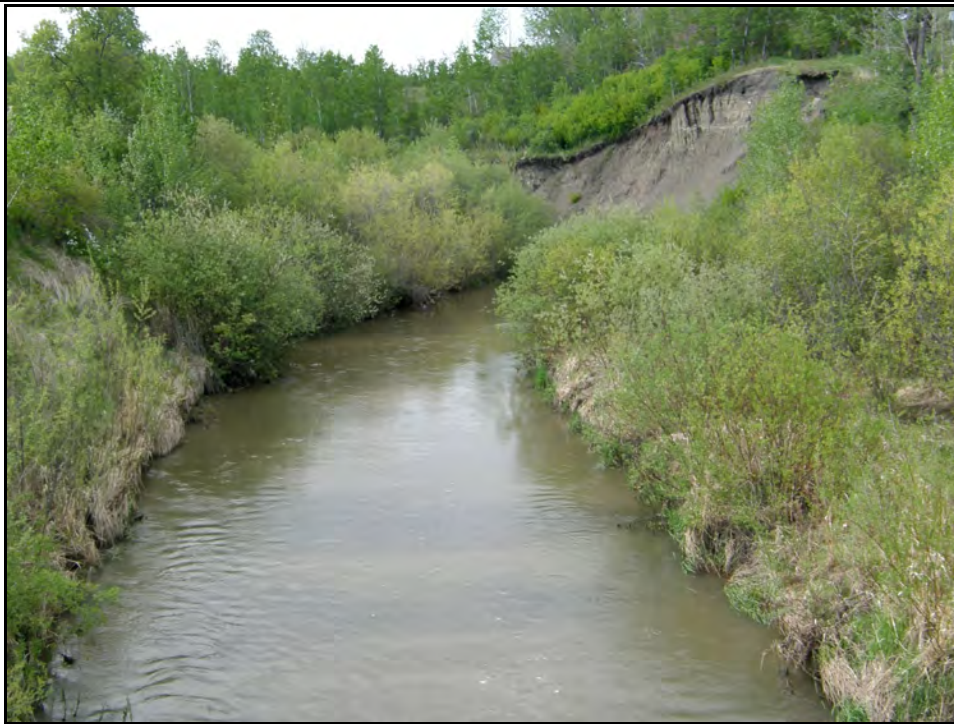
**Photograph 23:** Typical vegetated section between 96 and 90 Avenue, with oversteepened unvegetated slopes at the outside creek bends, particularly evident where topographic high points occur along the creek.

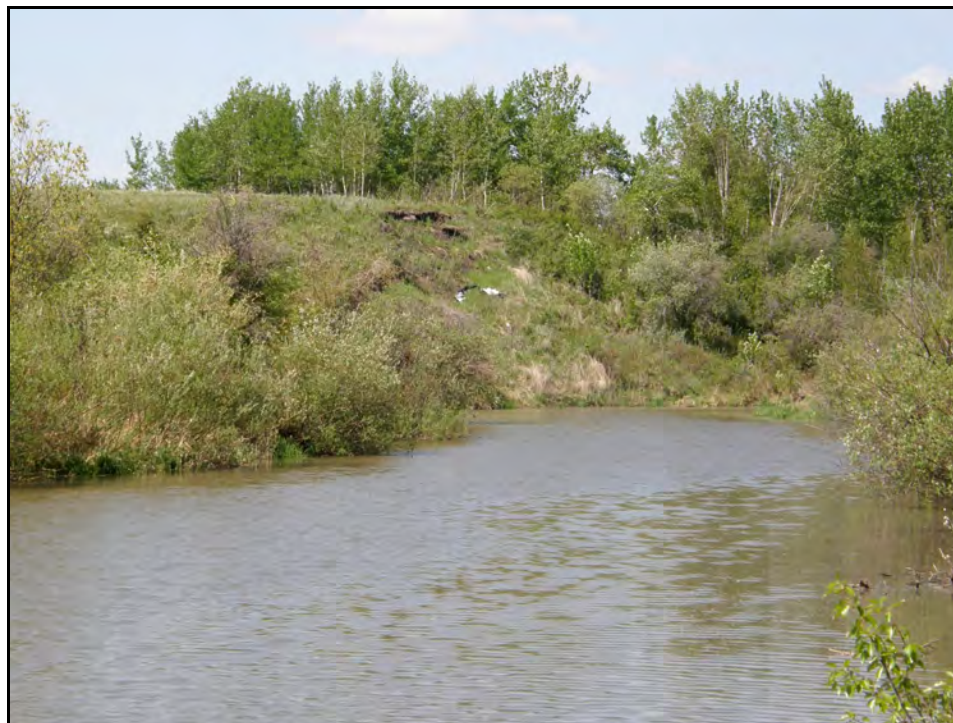
**Photograph 24:** Slopes at inclinations of about 2.5 (H) to 1(V) are more stable due to better vegetative cover, but are still susceptible to toe erosion induced failures. This is a surficial failure that does not extend significantly back from the slope face. With the eventual loss of the vegetation, this slope would be prone to a larger regressive rotational failure that would extent much further back.

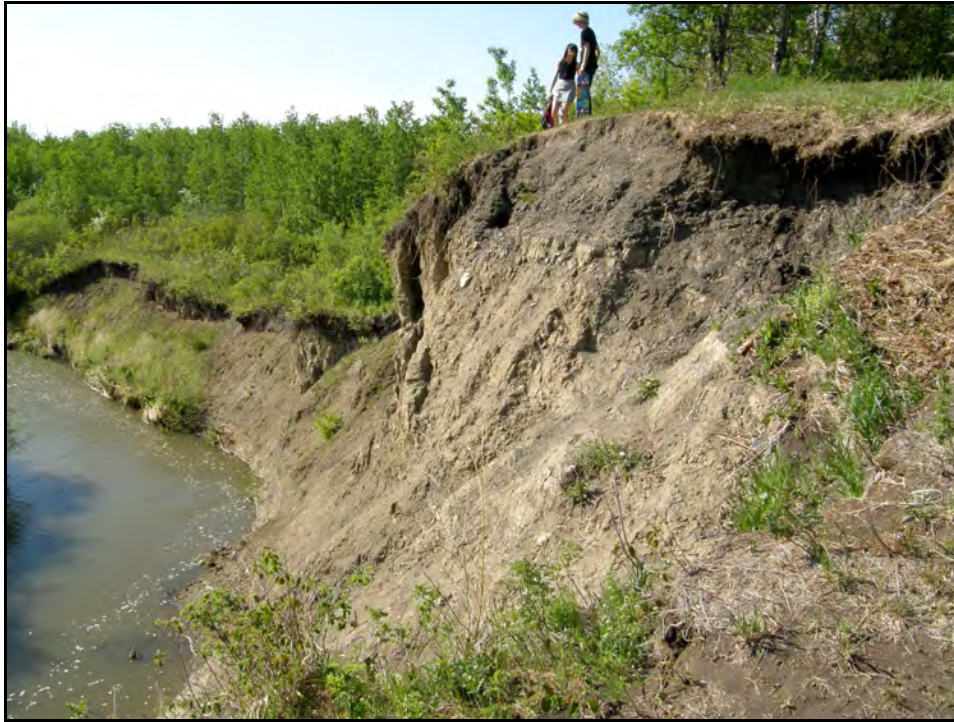
**Photograph 25:** Lateral migration of the slope face is occurring due to weathering and toe erosion. Most areas have residential developments further back from the slope to not be at risk from large failures, particularly along 102 Street between 86 and 100 Avenue.

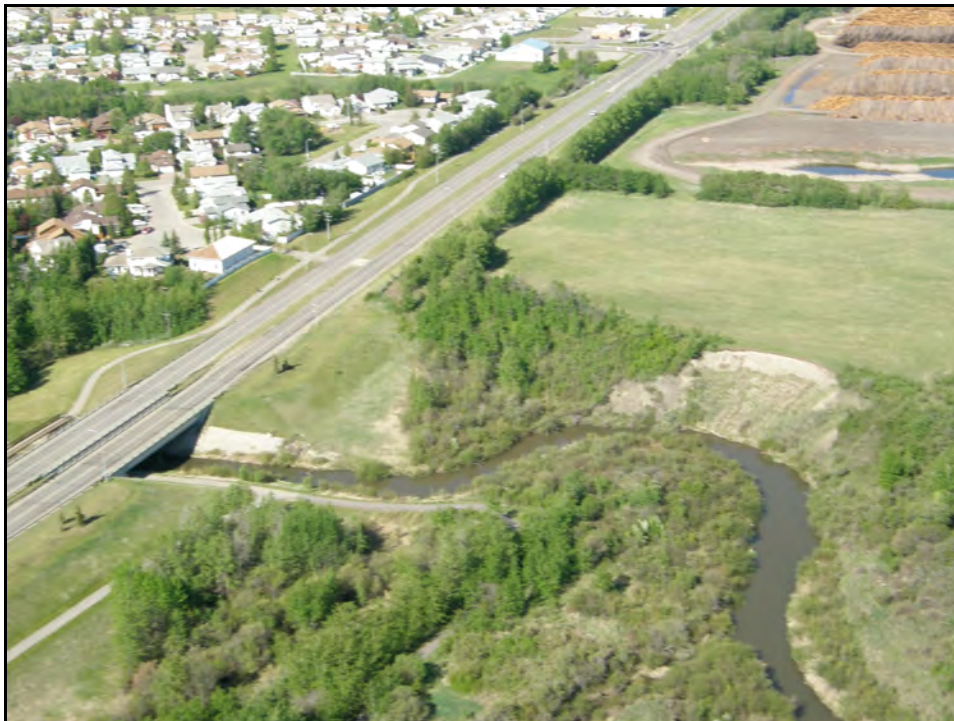
**Photograph 28:** Failure located east of Canfor along the north side of 84 Avenue. The creek has been straightened from immediately north of the bridge to at least 60 m south. Although vegetation is starting to establish on the slope face within the failure zone, continued erosion by the creek due to the very sharp bend will likely result in further regression until a more stable angle is reached.

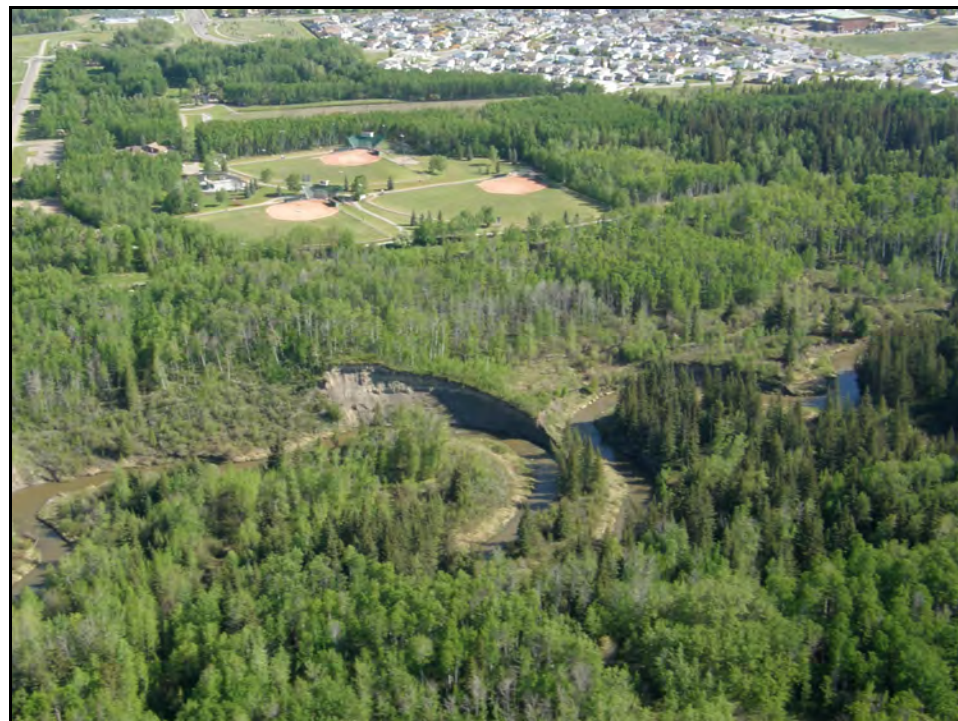
**Photograph 42:** Looking north. The ball diamonds east of 100 Street are in the background. The valley is deeper in this area, with steeper slopes, with evidence of current and historical landslide activity being observed. No developments were located immediately adjacent to this portion of Bear Creek.

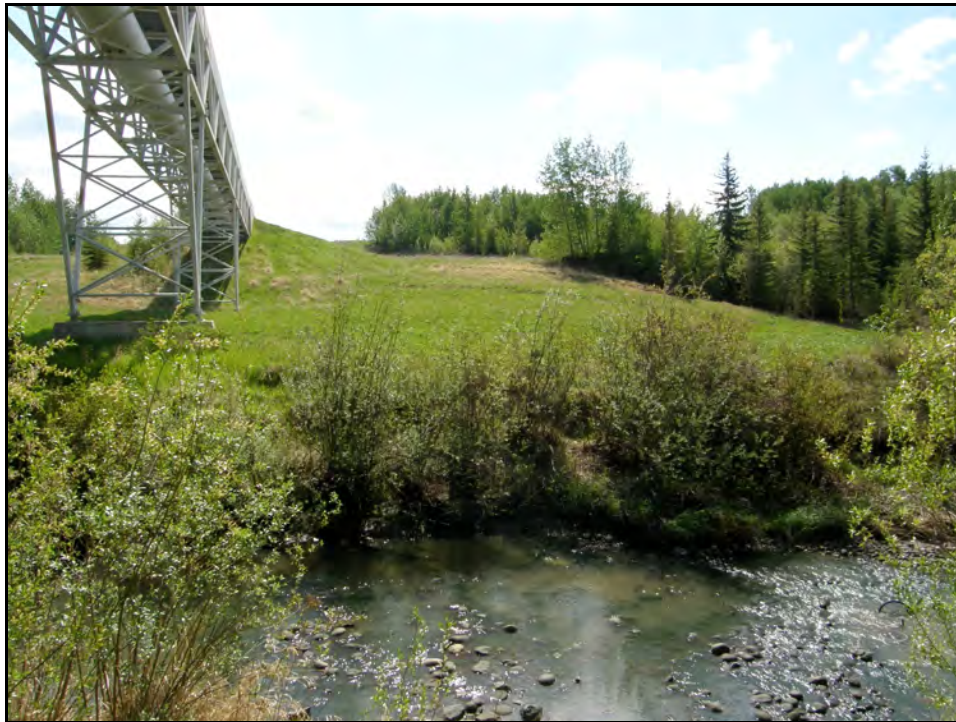
**Photograph 43:** Utility crossing with pedestrian access south of 68 Avenue, looking east. The gravel lines the stream bed, as erosion of the clay till has removed all clay and silt materials.

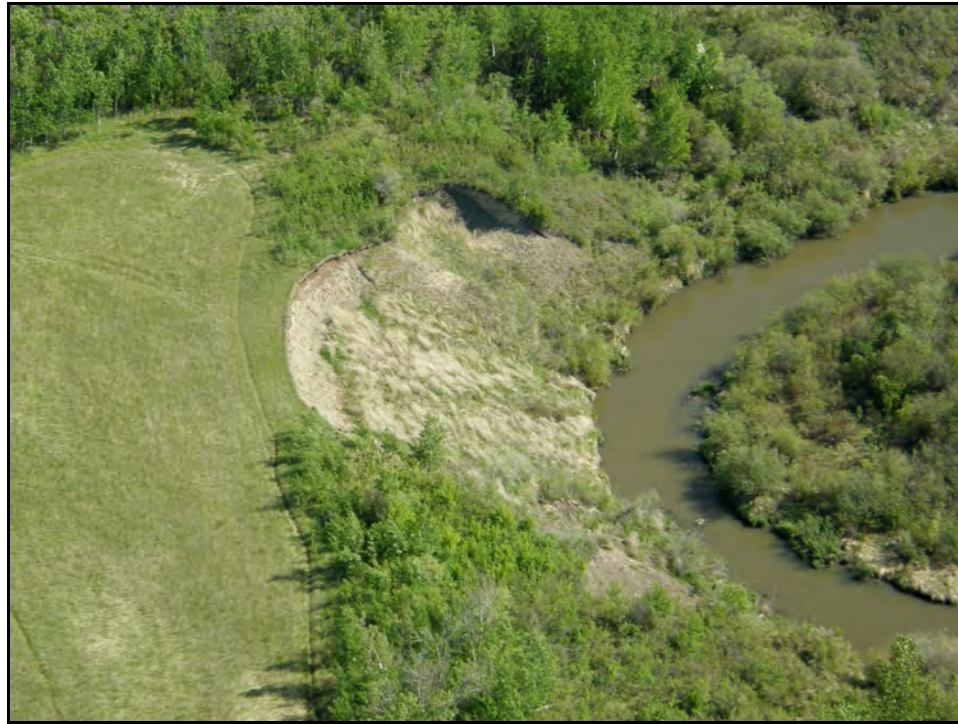
**Photograph 47:** Surficial sloughing failure at relatively shallow slope inclination, likely triggered by toe erosion.

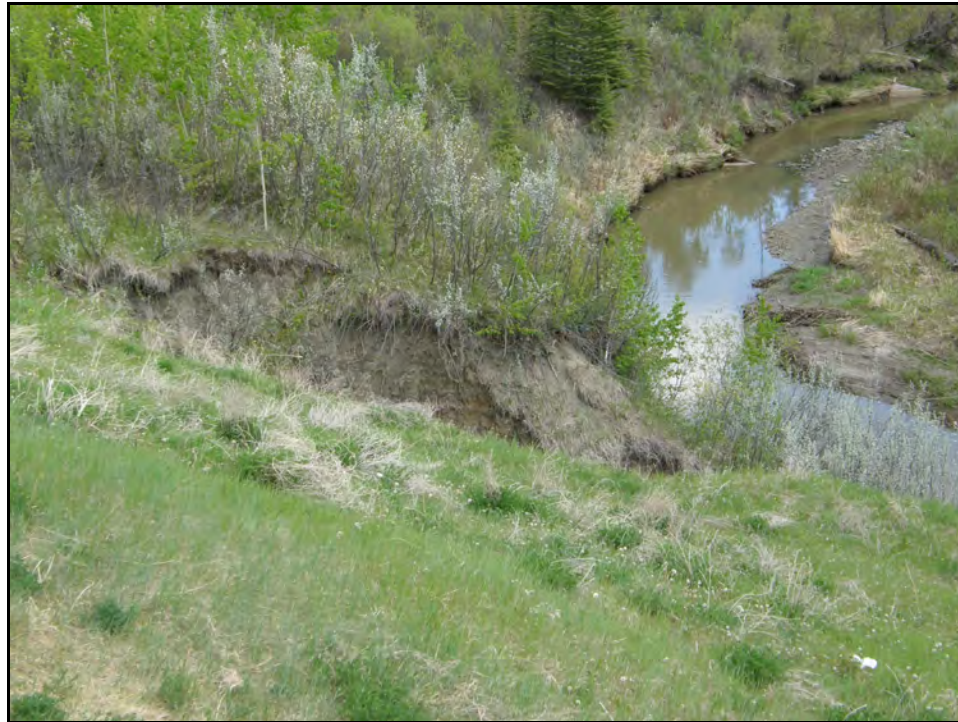
**Photograph 51:** Slope failure in the northeast abutment fill of the utilidor bridge located along 100 Street, likely caused by toe erosion.

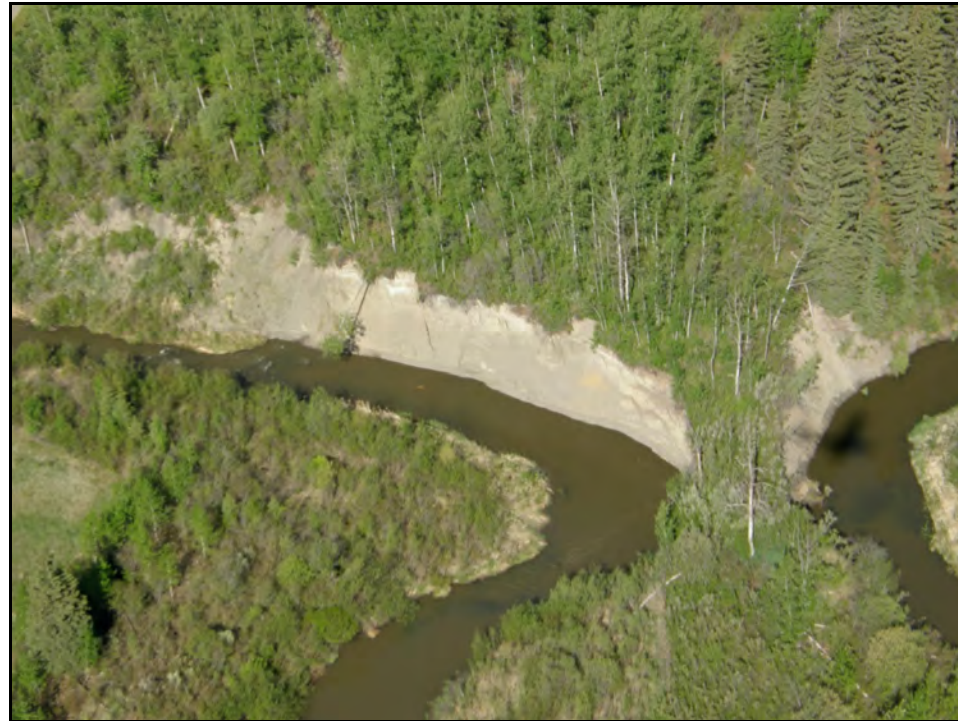
**Photograph 52:** Over-steepened slopes and side cutting which will form an oxbow. The slopes east of 100 Street were generally stable at steep inclinations than slopes further west and north, as the exposed soils were likely clay shale bedrock, and less susceptible to erosion.
