# BEAR CREEK CORRIDOR GEOHAZARD SLOPE STABILITY AND EROSION ASSESSMENT

GRANDE PRAIRIE, ALBERTA

THE CITY OF GRANDE PRAIRIE

PARKLAND GEOTECHNICAL LTD.

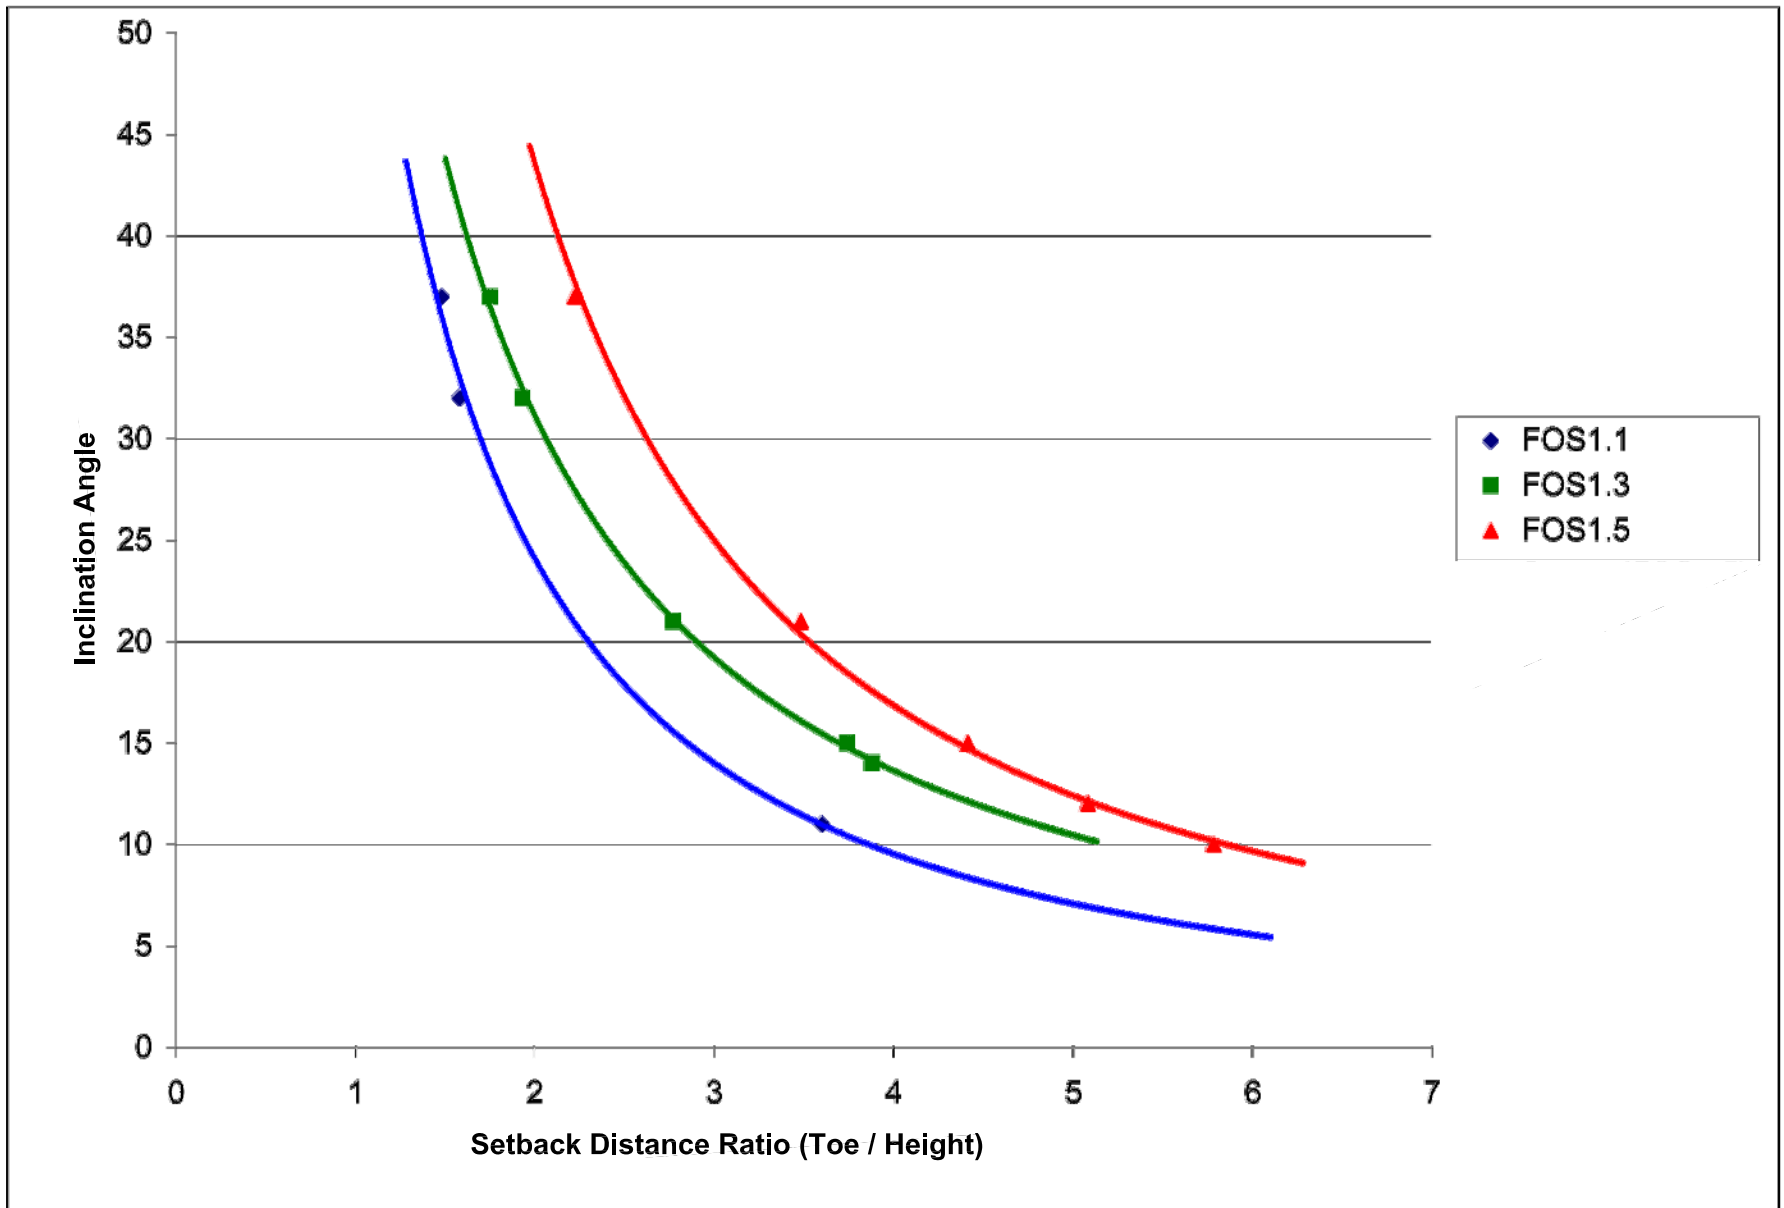
FIGURE 4: SETBACK DISTANCE VS. SLOPE INCLINATION

In order to predict the slope regression to a greater degree of accuracy, a series of characteristic failure curves was developed from the stability analyses. The curves (Figure 4) present the relationship between slope regression and inclination at three factors of safety (1.1, 1.3 and 1.5). A factor of safety of 1.1 was the lower bound that had a good correlation to observed behaviour, as relatively few sections had a factor of safety of 1.0. The curves present the potential slope regression, or more accurately setback distance, normalized to slope height. The design curves were most applicable to slopes over 5 m in height.

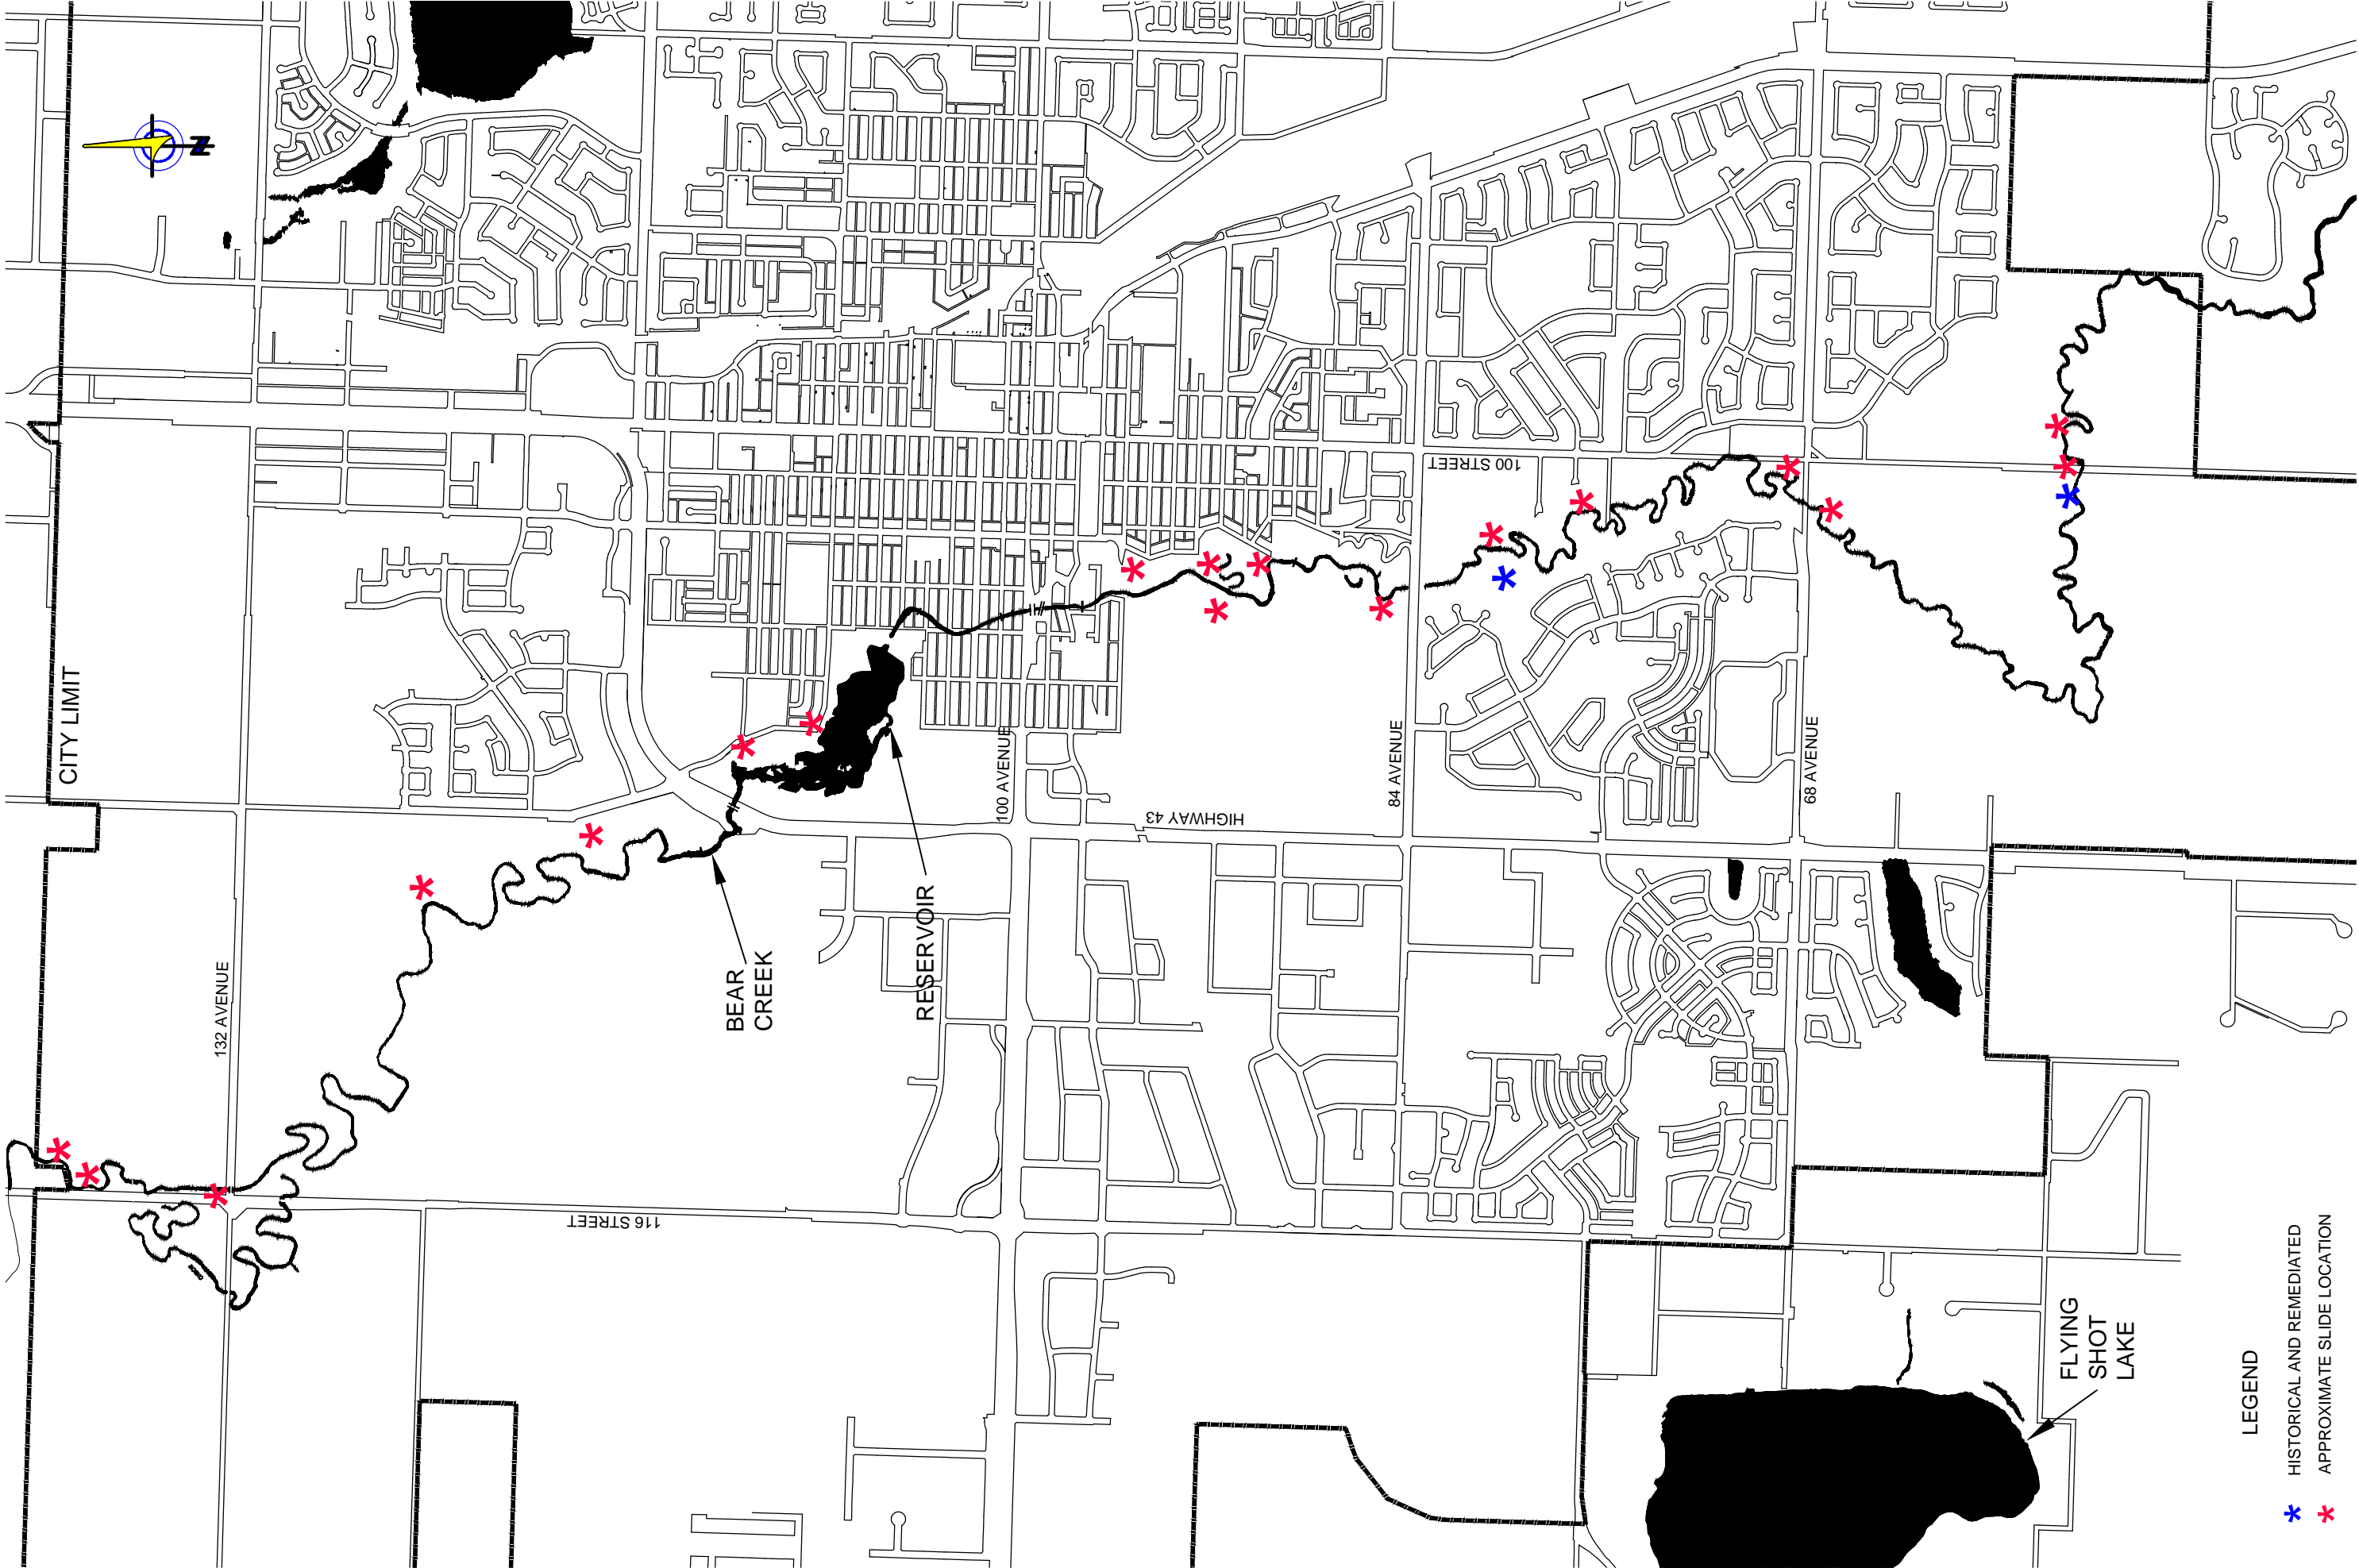
FIGURE 15: SLOPE FAILURE LOCATIONS

This study was not intended to be a catalogue or inventory of landslides. There were over one hundred identified in 2009/2010, many of which were very small slumps (less than 300 m<sup>3</sup> in soil volume), but several larger failures were found (in excess of 5000 m<sup>3</sup>), along with numerous slides of between 1000 and 2000 m<sup>3</sup>.

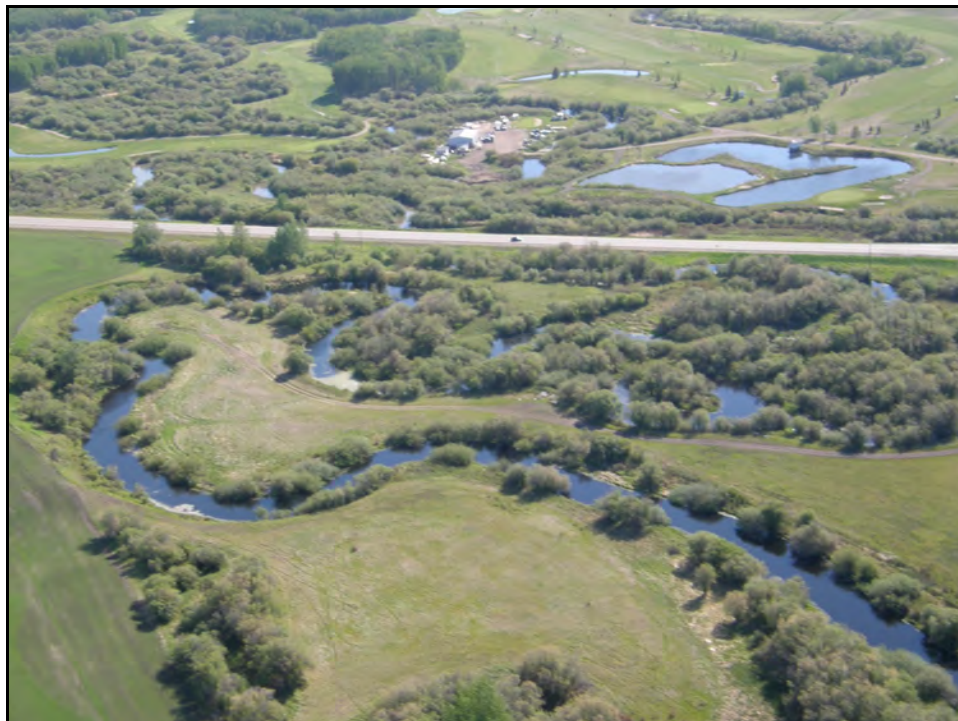
Immediately north of the City limit, Bear Creek passes below 116 Street and turns southwards past two acreage residences and the Bear Creek Golf Club (Photograph 2). This portion of the creek has been significantly modified by development of 116 Street, with an old creek channel and oxbow lakes present on the west side of 116 Street. About 80% of the creek leading down to 132 Avenue was a man-made channel.

**Photograph 2:** Meandering oxbows (bottom portion of photo) along cut off portion of Bear Creek just south of the north City Limit. The active Bear Creek is located east of 116 Street (top portion of photograph - north is to the left).

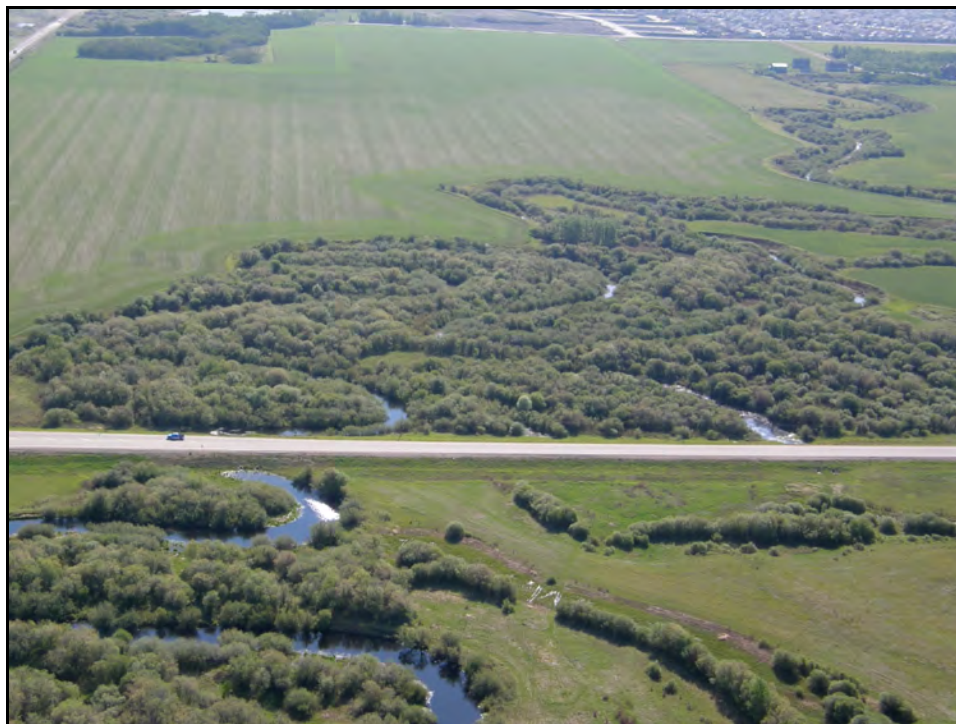
South of 132 Avenue the creek enters a large wetland area located in the northwest corner of the NW1/4-34-71-6-W6M (Photograph 6). In this area the creek channel is difficult to identify.

**Photograph 6:** Looking east at dead oxbows west of 116 Street and the active and creek channel with low areas to the east. Bear Creek becomes progressively deeper towards the southeast (the Royal Oaks district is in the background).

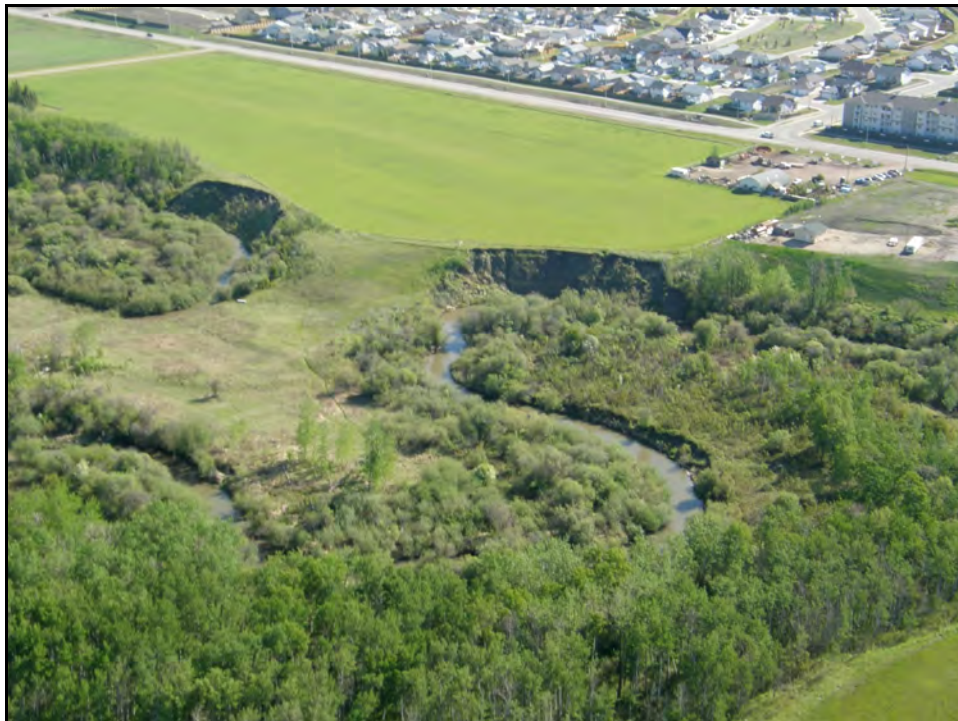
Within the southeast portion of the section, the creek turns to the south and passes through the remainder of the quarter section. Here the creek begins to cut deeper into the subsoils and widen, with several outside bends beginning to show signs that the creek will cut through the outside slope and form an oxbow lake within the next 50 to 100 years. The slope heights increase to around 6 to 12 m (Photograph 8).

**Photograph 8:** Meanders and two distinct over-steepened areas immediately northwest of the People's Church development. A detailed setback study would be required for the entire length of Bear Creek through this quarter section prior to development.

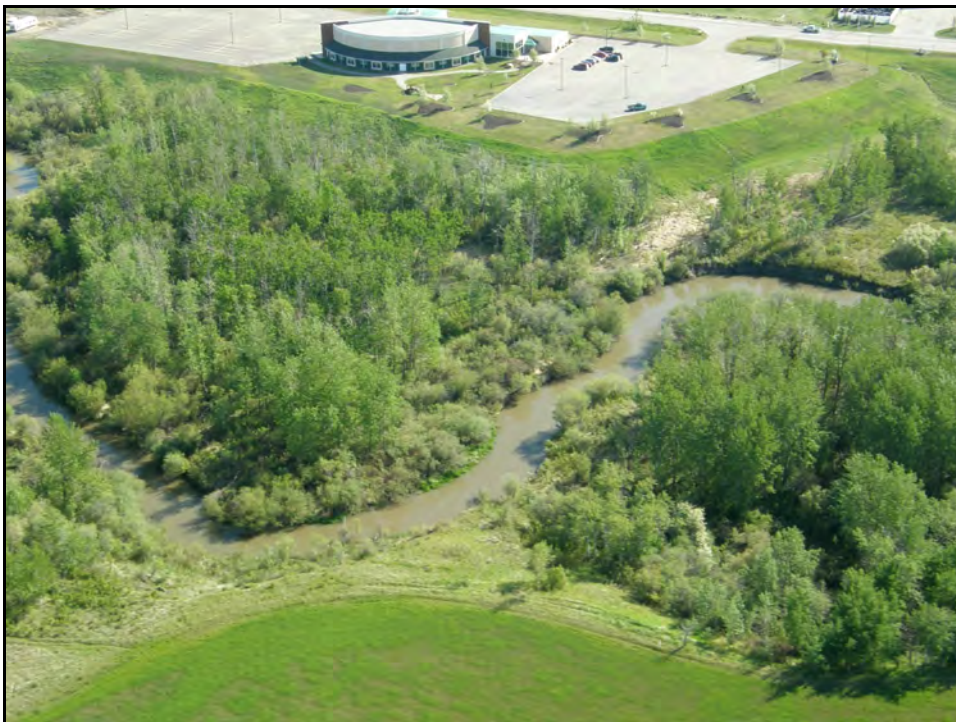
At the south end of the area, near the bypass road, the original creek channel has been pushed westwards by infilling a portion of the valley by a development on the eastern river bank (Photograph 10). It is also just downstream of this area, that the first of the City storm outfalls discharge into Bear Creek. The river then crosses the bypass road and discharges into the Reservoir. Beaver activity was observed in this area.

**Photograph 10:** Relatively stable slopes near the Peoples Church facility, north of the by-pass road (Highway 43) and west of 108 Street. Infilling of the old channel pushed Bear Creek further west, which has contributed to the overall stability and lack of erosion near the developed area.

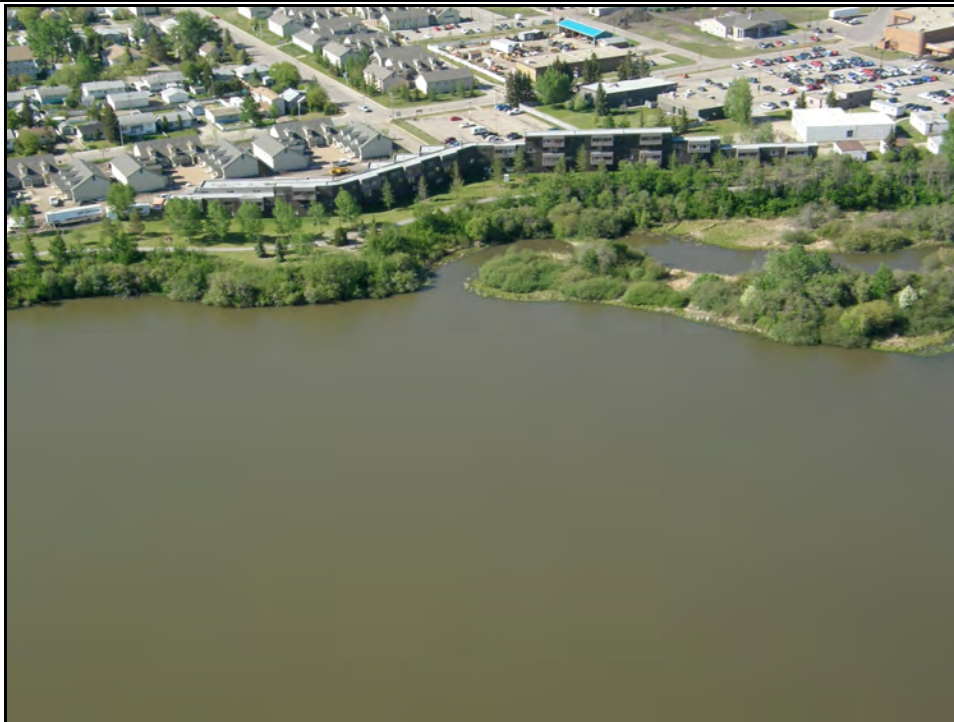
Bear Creek then enters a stormwater reservoir, which was formerly a natural wetland but has been modified and enlarged to accommodate the stormflows (Photograph 11). The area surrounding the reservoir includes gentle slopes along the entire perimeter, with urban parkland on the north shore, and the Grande Prairie Regional College campus along a large portion of the south shore.

**Photograph 11:** Looking south across the Reservoir with Grande Prairie Regional College in the background. The reservoir is very shallow throughout much of the area, with the water depth being typically less than 300 mm. A slightly deeper channel is located running the length of the reservoir, located at the bottom of the photo.

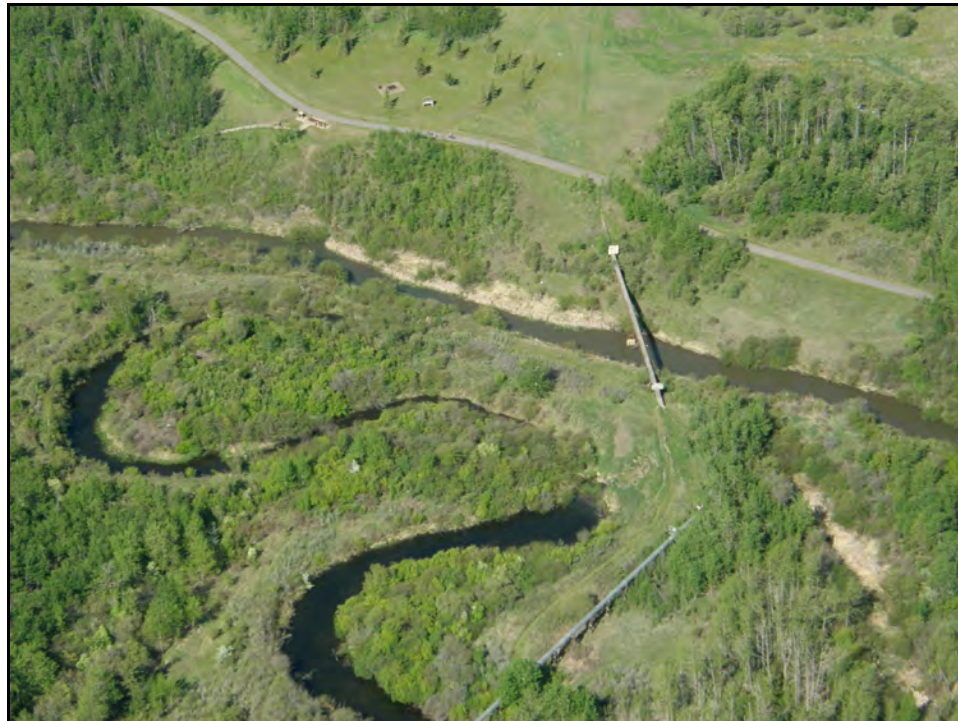
**Photograph 21:** Utilidor Bridge crossing the Bear Creek. A large oxbow is visible in the picture foreground. The straight alignment of the creek indicates that this portion of the channel had been straightened, likely to avoid instability issues.

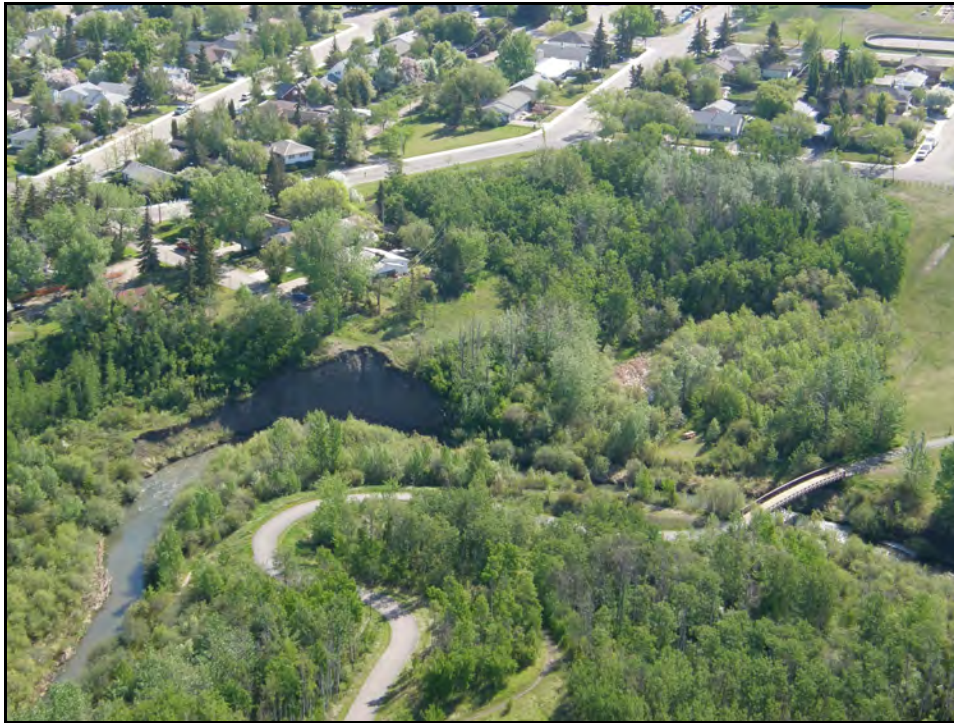
**Photograph 27:** Over-steepened slope coincident with a topographic rise and an outside bed along Bear Creek.

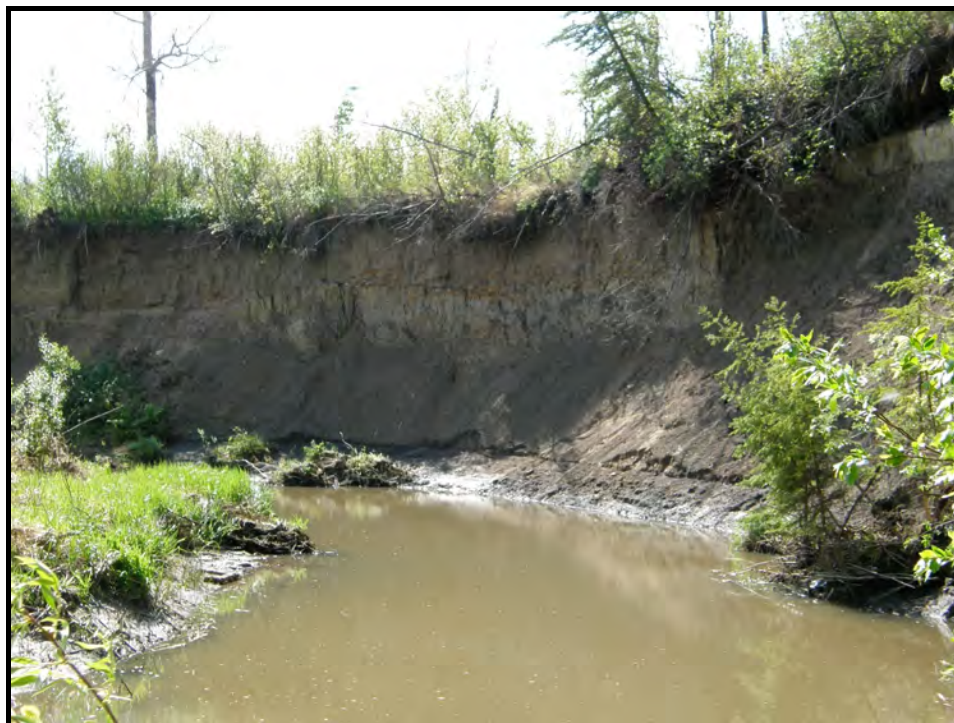
**Photograph 34:** Typical over-steepened outside bend along creek. The creek has cut through the upper lacustrine deposits (upper light brown soil) and is within the deeper clay till (darker soil) which is relatively stronger than the upper material.

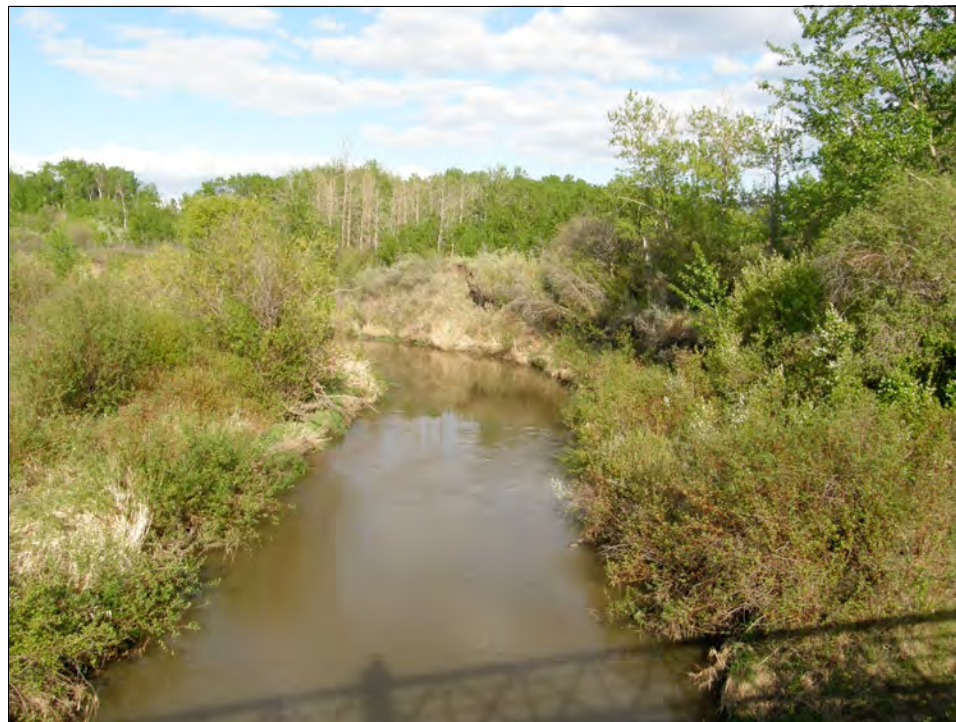
**Photograph 35:** Relatively stable section of the creek, with thick grass vegetation minimizing erosion. Minor erosion at the water line is evident but lateral migration of the channel is minimized. The hummocky terrain indicates that this area was likely a historic landslide area.

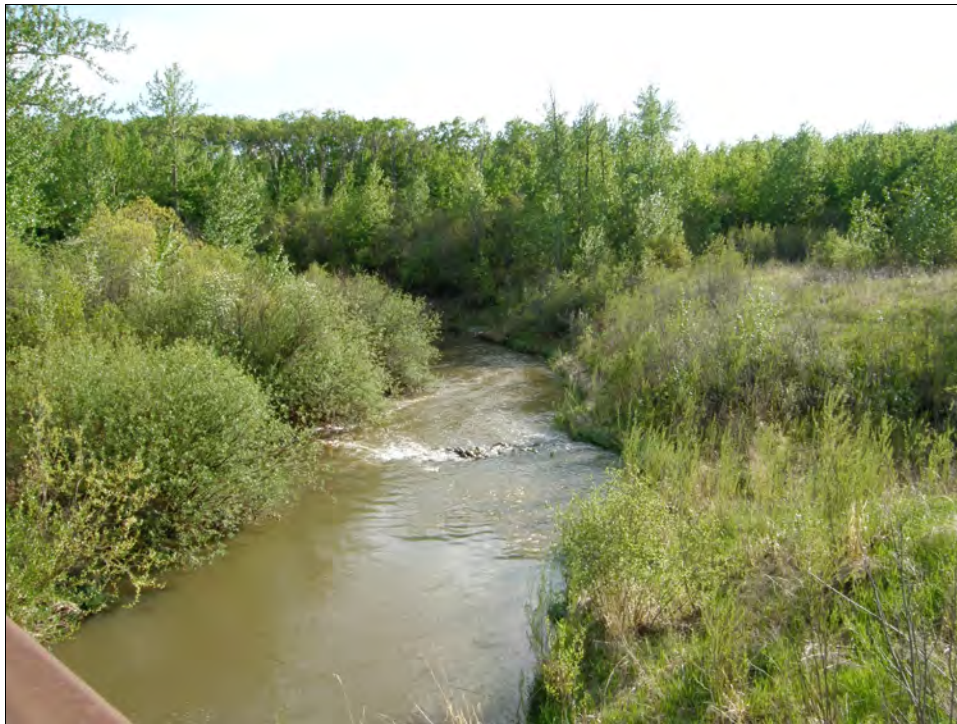
**Photograph 36:** Looking along Bear Creek from a footbridge crossing around 71 Avenue. Relatively low stream velocities have allowed thicker vegetation to establish in this area. There were generally fewer tight bends in the channel which minimized outside bends.

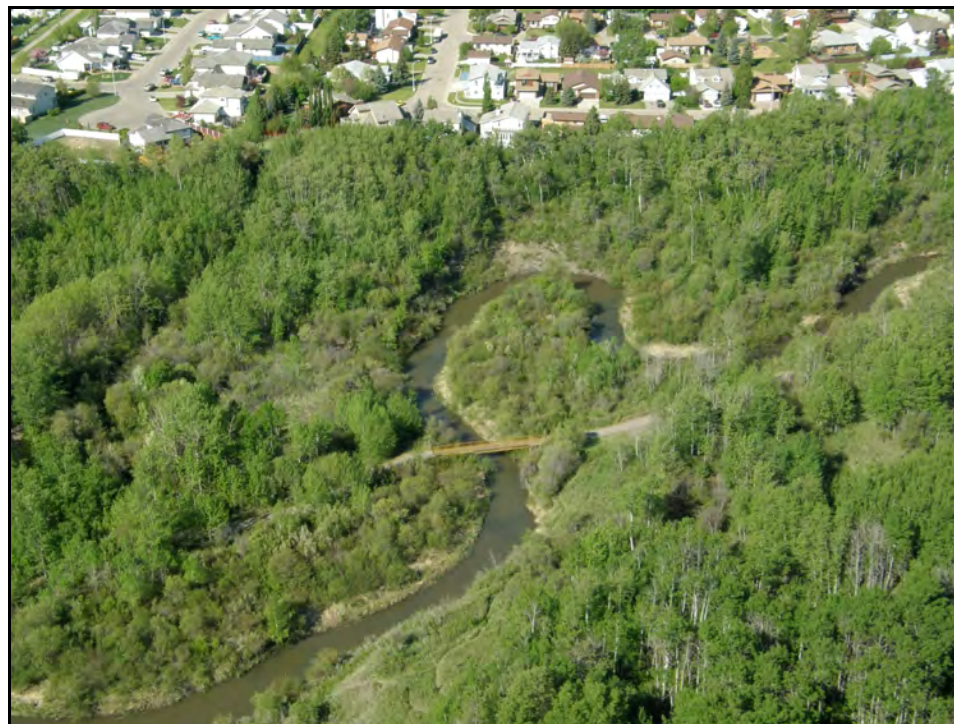
Further to the south, the creek becomes more meandering, with about five of the meanders nearly forming oxbow lakes. A new oxbow lake was observed to have formed at about 74 Avenue within the last 2 to 5 years. With the current rate of erosion, it is likely that at least three new oxbow lakes are likely to form in the next one to two decades (Photographs 39 and 40). This will likely result in changes to the downstream hydrology.

**Photograph 39:** Looking southwest at the creek immediately north of the 68 Avenue bridge, showing very tight bends that will likely result in new oxbow formations. The new bridge crossing at 68 Avenue displays less obvious signs of straightening or stream alteration.

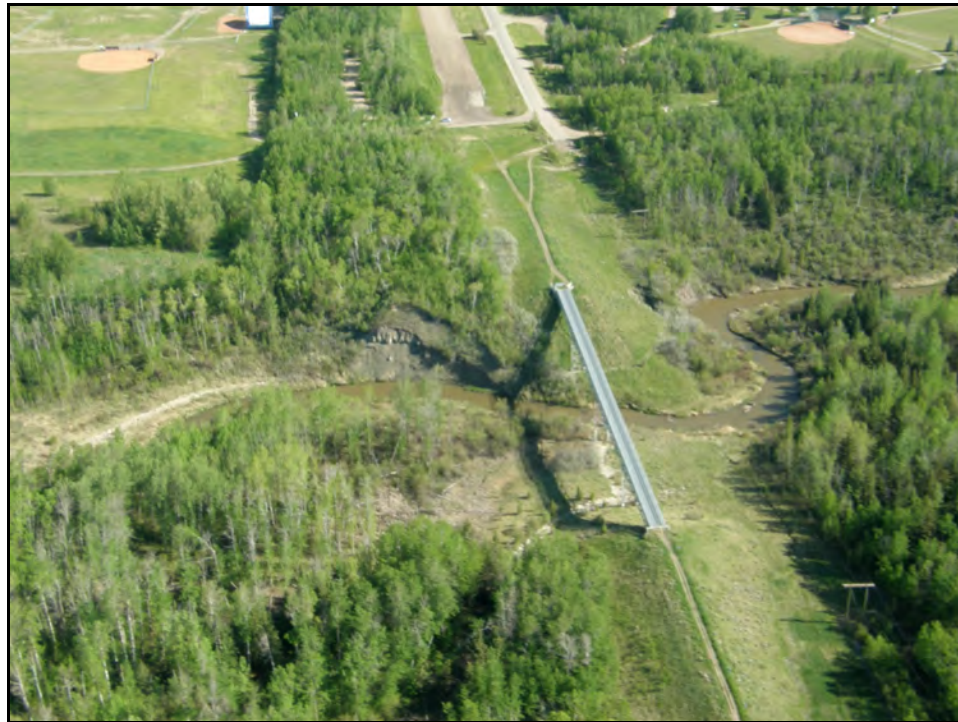
**Photograph 40:** Typical section of creek in the areas north of 68 Avenue, with wide natural areas between the creek and the residential developments allowing an adequate buffer to minimize the impacts of potential slope failures.

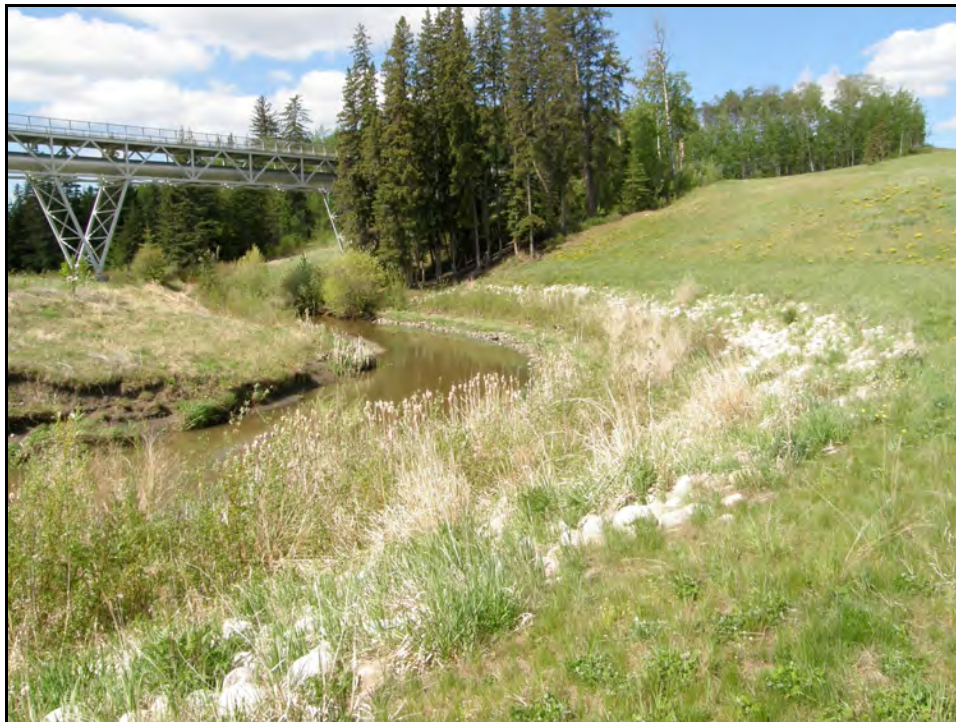
**Photograph 43:** Utility crossing with pedestrian access south of 68 Avenue, looking east. The gravel lines the stream bed, as erosion of the clay till has removed all clay and silt materials.

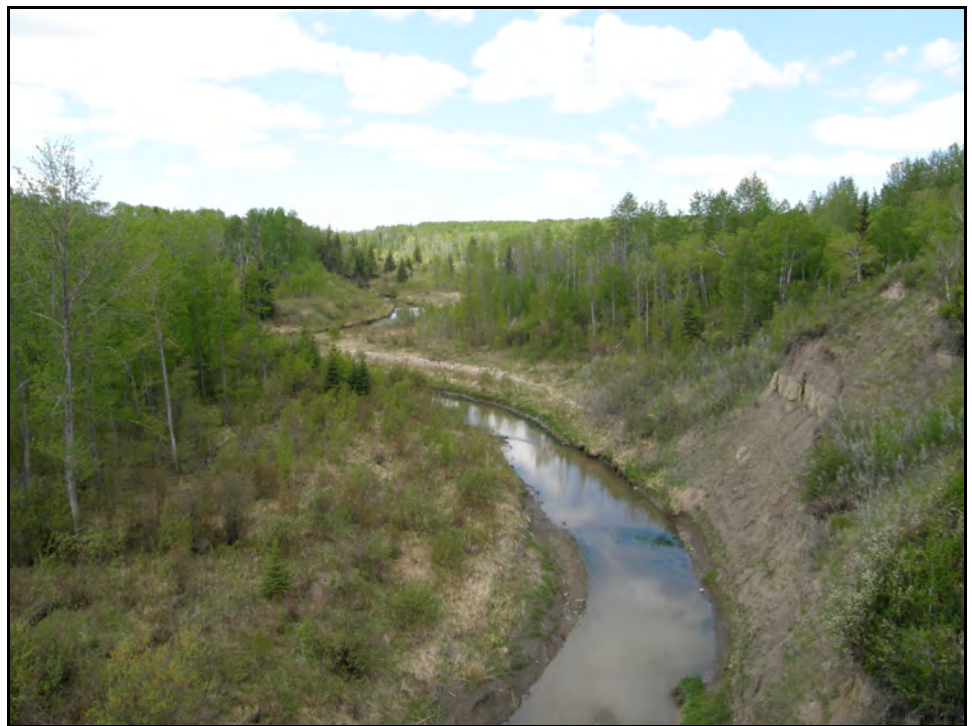
**Photograph 45:** Typical stream south of 68 Avenue, with more gravel and cobbles along the stream bed. There is minimal residential development south of this area. The valley becomes deeper, further to the south and to the east. Bear Creek is downcutting through clay till and clayshale bedrock in these areas which is a change in geology and will result in different slope profiles and behavior.
